## **Sand Abrasion Resistance of Oxifree TM198 Coating System**

4/3/2013

ASTM D968 Standard Test Methods for Abrasion Resistance of Organic Coatings by Falling Abrasive.

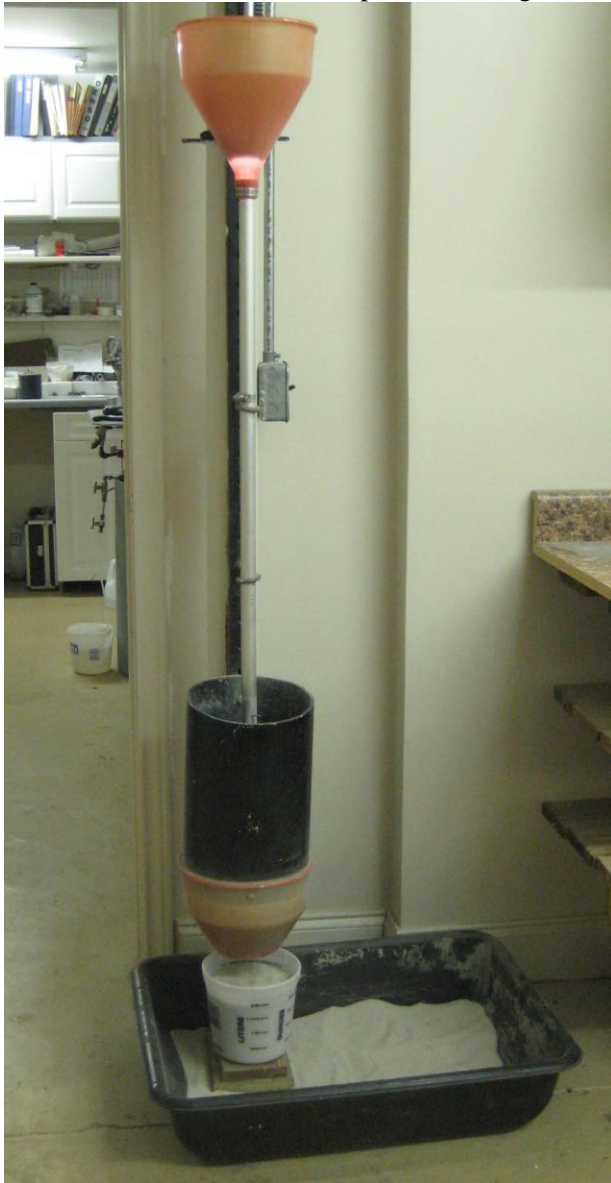
**Fig. 1 ASTM D968 Sand Abrasion Test Apparatus**

The test apparatus is shown in Figure 1. A total of 200 liters of the standard abrasive specified in the ASTM D968 Standard was directed onto the surface at 45 degree. The thickness in the test area was compared to the thickness in the same area prior to testing. The test area was also examined under a microscope.

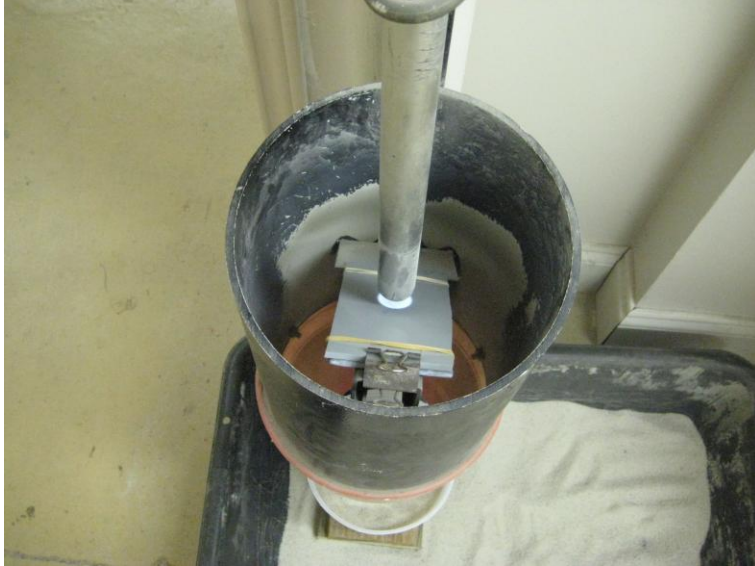
**Fig.2 The Sand Abrasion Test Sample at 45 Degree to the Falling Sand.**

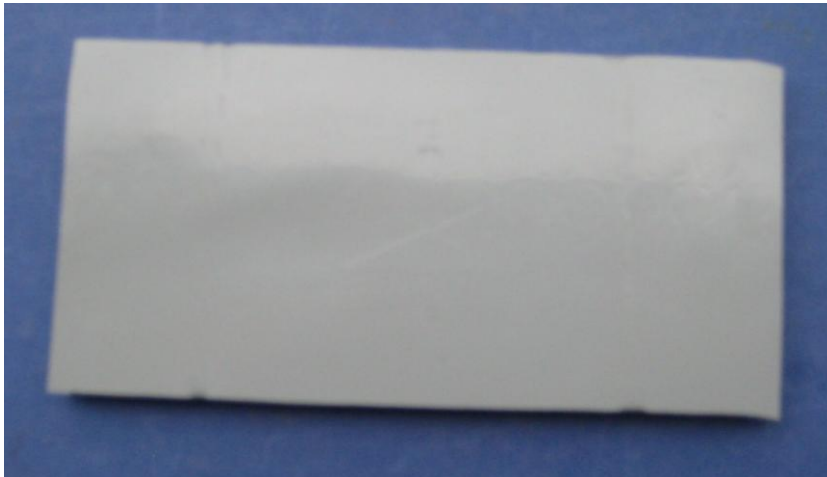
**Fig. 3 Sand Abrasion Test Sample, 3” x 6” x 4 mm (thickness)**

Test sample 3”x 6” x 4mm (thickness) prepared by Oxifree Co is shown in Figure 3. .

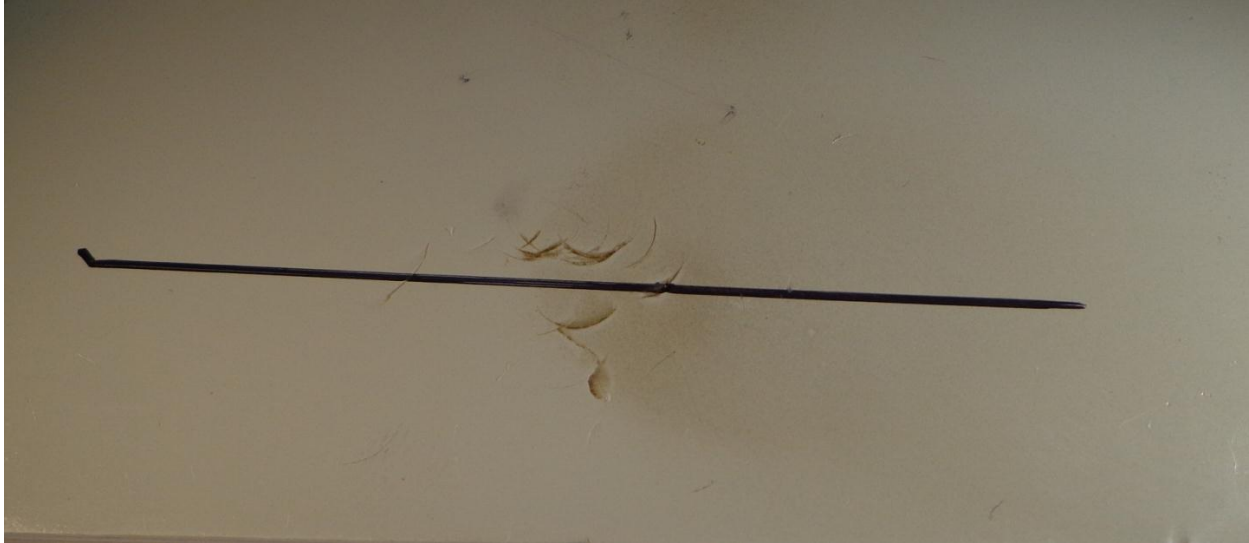
**Fig 4 Oxifree TM198 Coating after ASTM D968 Sand Abrasion Test**

The black line is from a permanent marker and was drawn after testing was completed. The crescent marks are cuts from the sharp edge of the micrometer made during measurement attempts.

The sample after sand abrasion test is shown in Figure 4. There was little measurable DFT loss as determined by thickness readings using a micrometer after 200 liters of sand falling on the sample. The sand abrasion of the sample is estimated to be 0.5 mil at most. The sand abrasion resistance is 400 liters per mil of Oxifree TM198 Coating. In comparison with epoxy coating, the typical sand abrasion value would be about 40 liters per mil of epoxy coating. Therefore, the sand abrasion resistance of the elastomeric Oxifree TM198 coating is much better than a hard epoxy coating.
