# Test Report

## Corrosion Resistance of Oxifree TM198 Coating System

8/19/2013

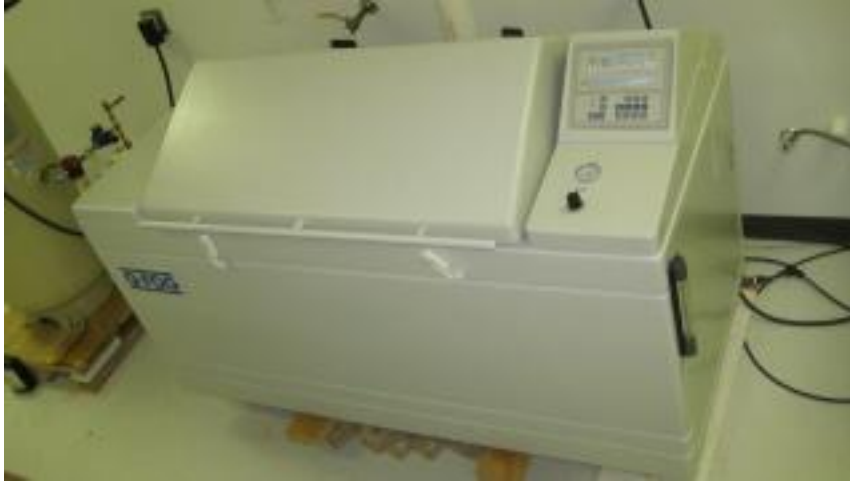
Figure 1 Q-fog Chamber for the Corrosion Resistance Testing, ASTM B117

ASTM B117 Practice for Operating Salt Spray (Fog) Apparatus. The Q-fog chamber is shown in Fig. 1.

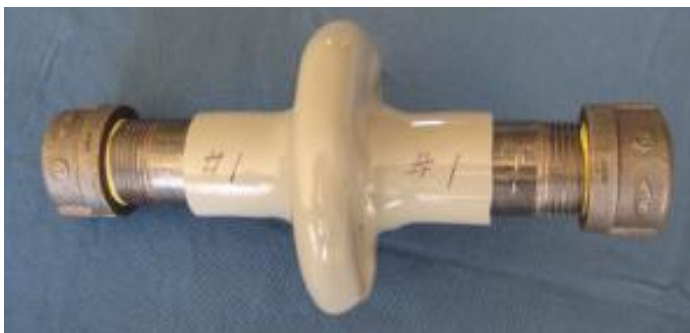
Fig. 2 A New Coated Flanged Sample, steel tube OD= 1.325", both ends capped with some bare metals exposed

Three steel flange samples over-coated with Oxifree TM198 coating system were prepared by Oxifree Co. The test samples are listed in Table 1. A new coated flange sample is shown in Figure 2.

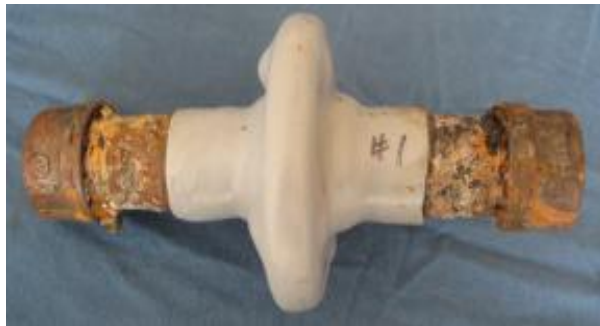
Fig.3A Flange #1 – After 3,000 Hr Salt Fog

After 3,000 hr ASTM B117 salt fog exposure, the steel flange samples before and after coating cutout are shown in Fig 3. The test results are listed in Table 2.

Sample	Sample ID	DFT, mm	Test Time, Hr	Corrosion Resistance
Coated Steel Flange	121009-1	2.8	3,000	No rusting on flange
	121009-3	3.1	3,000	No rusting on flange
	121009-4	2.4	3,000	No rusting on flange

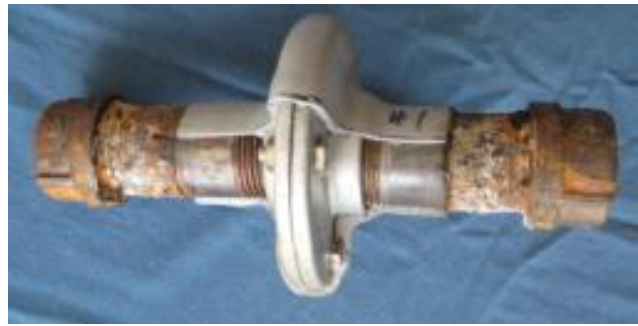
Fig.3B Flange #1-After 3,000 hr Sal Fog with a Cutout

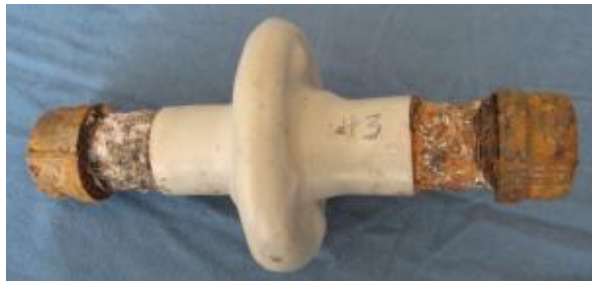
Fig.3C Flange #3 – After 3,000 Hr Salt Fog

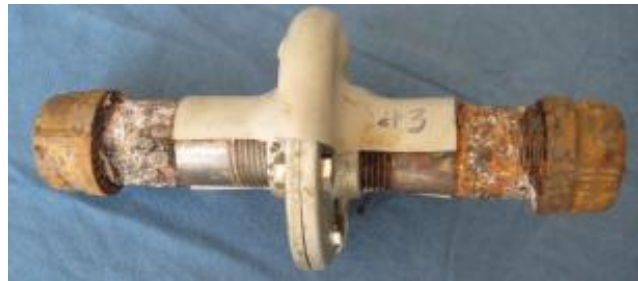
Fig.3D Flange #3-After 3,000 hr Sal Fog with a Cutout

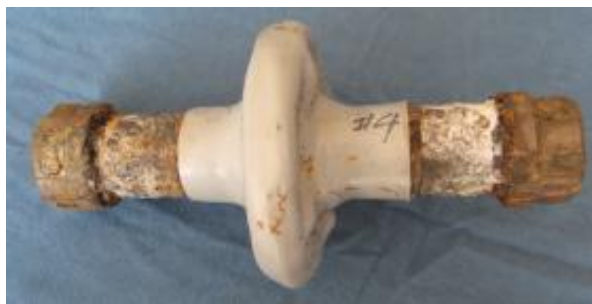
Fig.3E Flange #4 – After 3,000 Hr Salt Fog

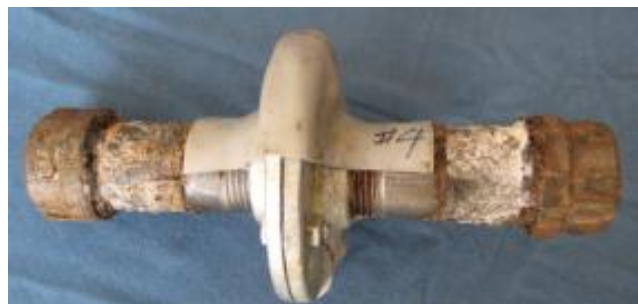
Fig.3F Flange #4-After 3,000 hr Sal Fog with a Cutout
