# Test Report

## **Accelerated Weathering Resistance of Oxifree TM198 Coating System – 3000 Hr Exposure Test Result**

7/24/2013

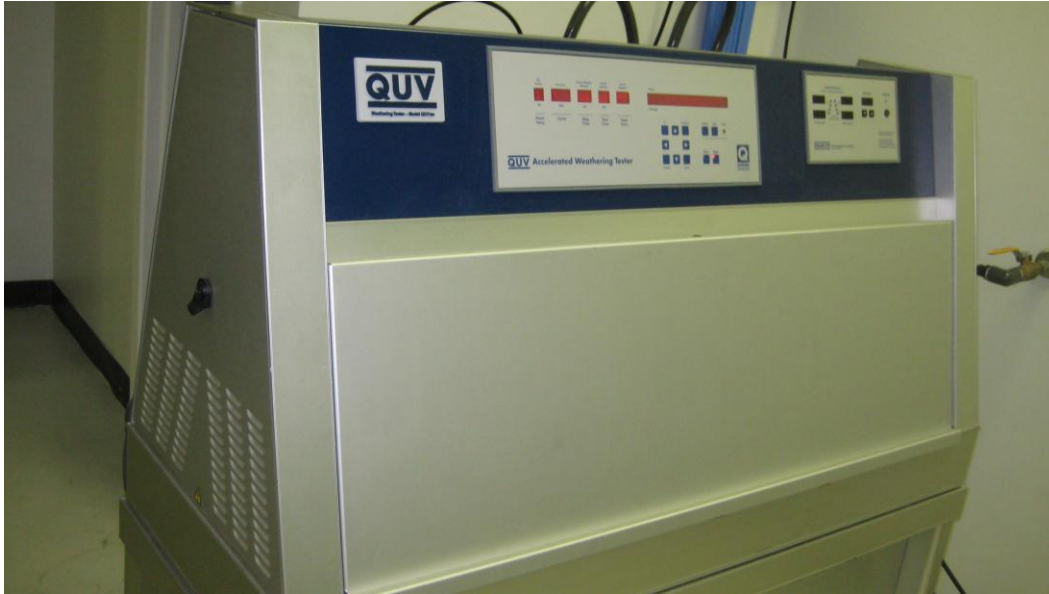
Fig 1 QUV Chamber for the ASTM G53 UV/Condensation Exposure

The accelerated weathering test is conducted in accordance with ASTM G53 “Standard Practice for Operating Light and Water-Exposure Apparatus (fluorescent UV-Condensation Type) for Exposure of Nonmetallic Materials” with a standard cycle of 4 hr UV at 60 °C + 4 hr Condensation at 50 °C. The QUV chamber is shown in Fig 1.

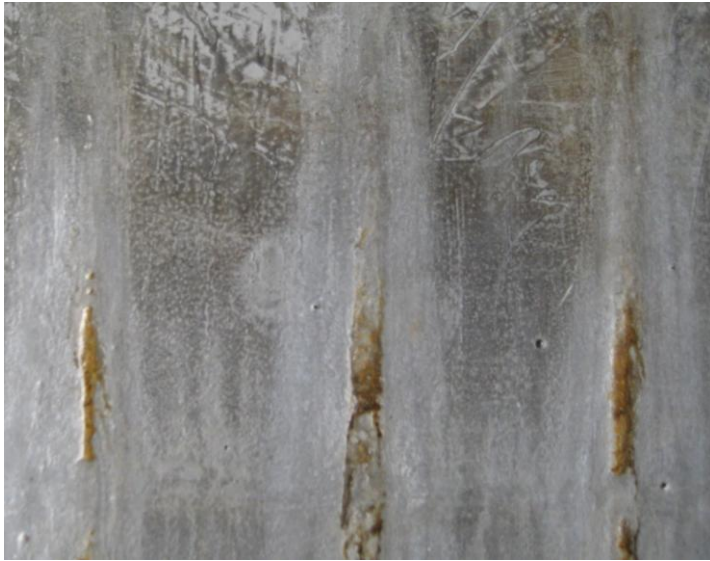
**Fig 3 Oxifree TM198 Sample after 3,000 hr ASTM G53 UV/Condensation Exposure. Oil oozes out to make a greasy surface.**

After 3,000 hr exposure to the ASTM G53 UV/Condensation cycles, No chalking can be detected. The sample surface shows a greasy appearance as shown in Figure 3 as a result of oozing out oil. The photos of the sample before and after the 3,000 hr exposure are shown in Figure 2 &3.
