Oxifree

DETEN Chemical Case Study

Location: Industrial Complex ,Bahia (BA)

Period: 26/03/08 to 03/04/08 (09 daily in the plant)

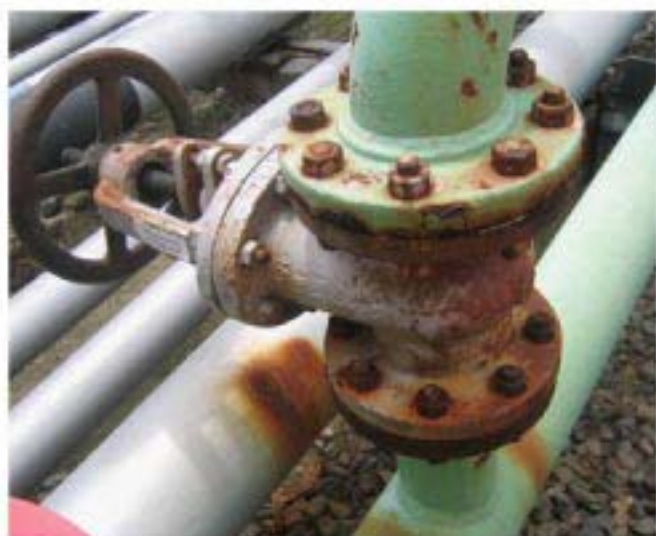
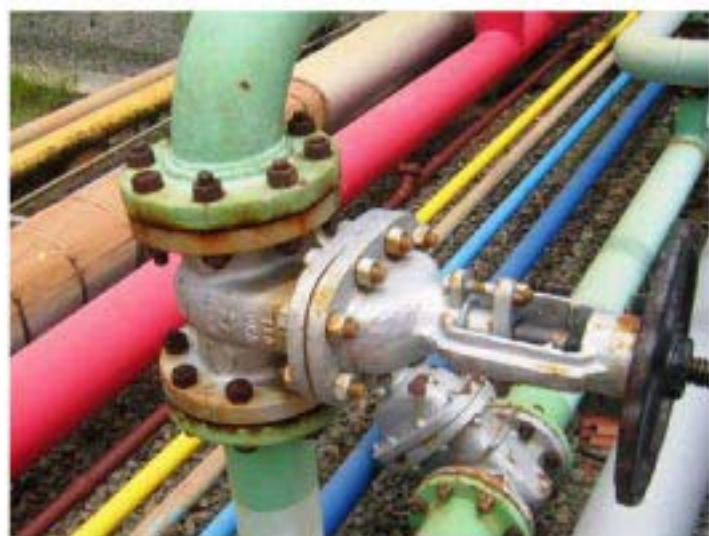
It has been found that there are pockets of corrosion in an advanced stage, due to chemical spills from the operation of the Tower. Once the corrosion cell is formed, the trend is that the damaged areas have aggravated the process along because of the aggressiveness of the plants products, combined with the corrosive action of the atmosphere combined with moisture in the air.

Gate valves with varying damage to almost all surfaces mainly due to galvanic corrosion

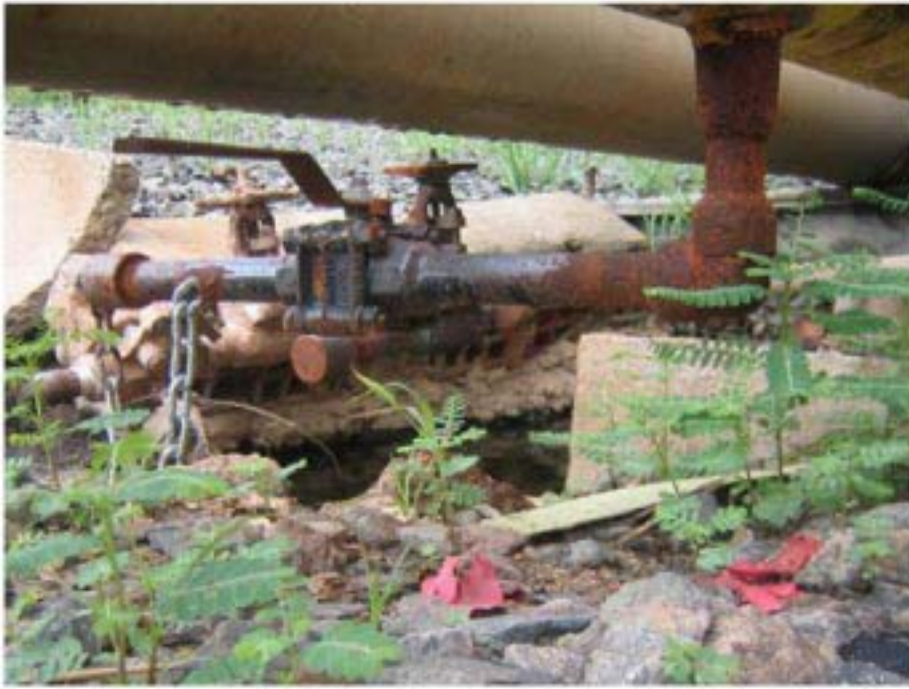
Ball valve with corrosion at its most critical on the elbow connector

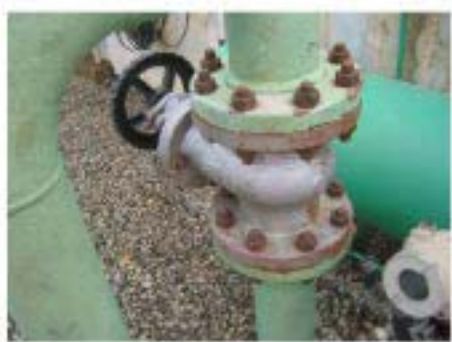
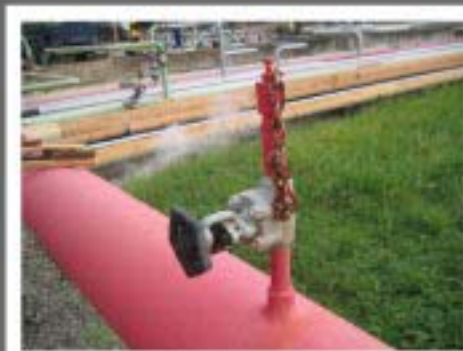
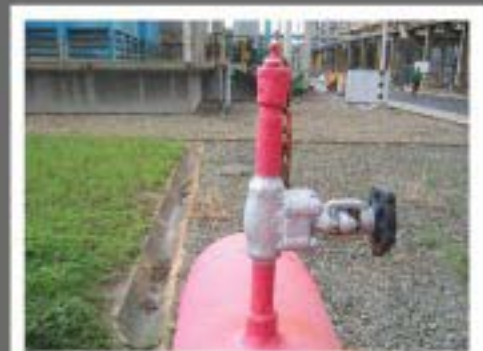
1.3 - After preparation

The surface preparation was completed by the use of a steel brush as well as 36 and 50 grain sandpaper. This enabled the removal of oxides and contaminants deposited on the components before the application of Oxifree.

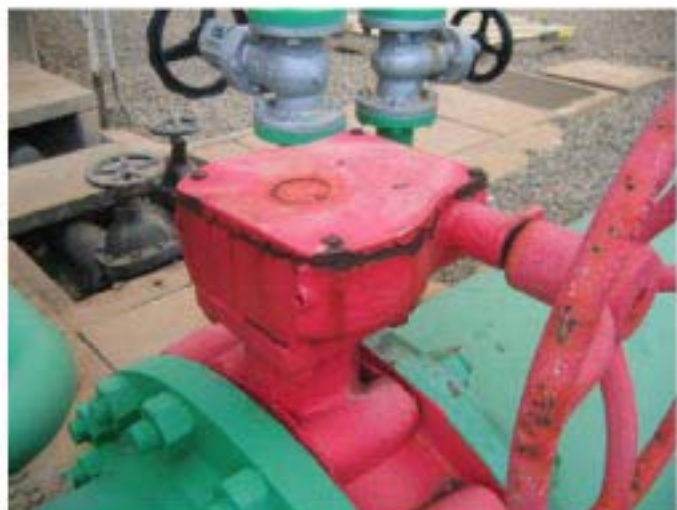
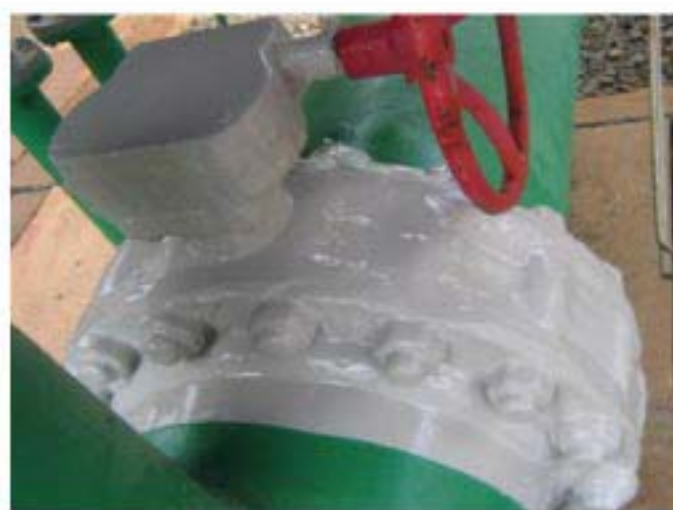
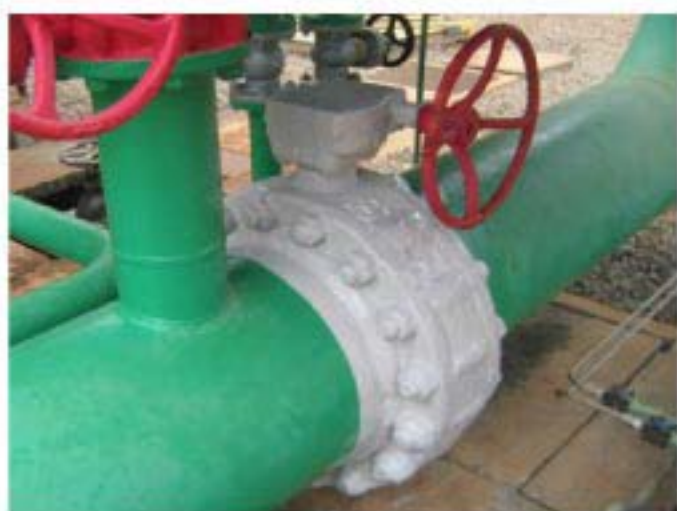
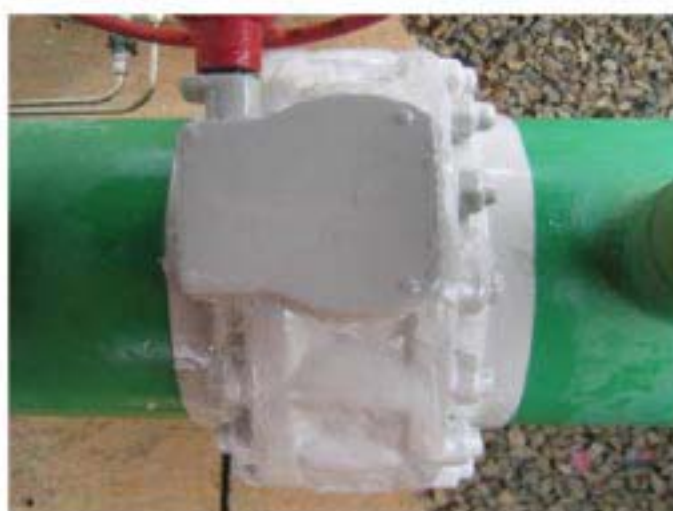
1.5A - Before and After the application

The mechanical components are sealed against a likely increase in the atmospheric corrosion process and because of the presence of sulphur oxides, which once reacted with moisture in the air leads to the formation of compounds such as aggressive H_2SO_4 . This phenomenon is called etching and causes a decrease in service life of valves and fittings of pipes.

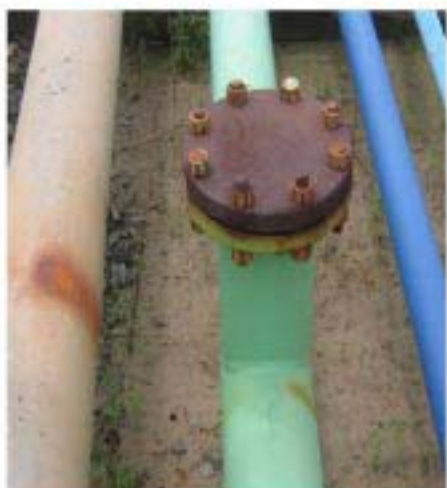
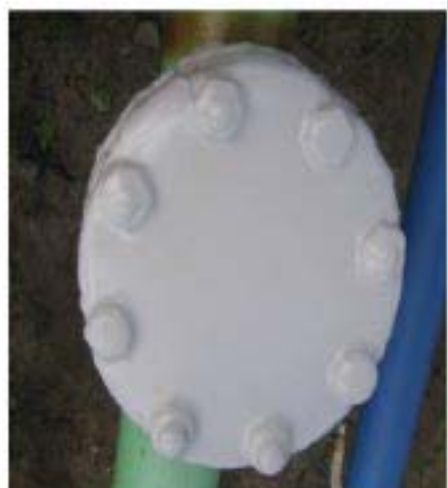
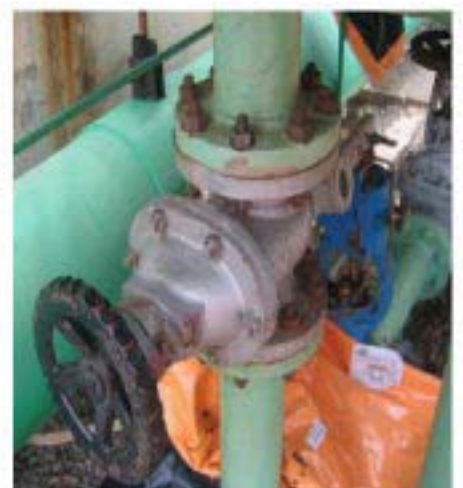
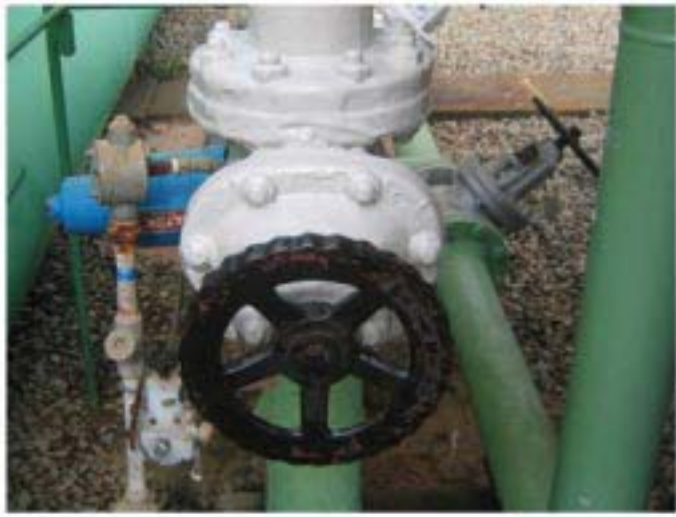
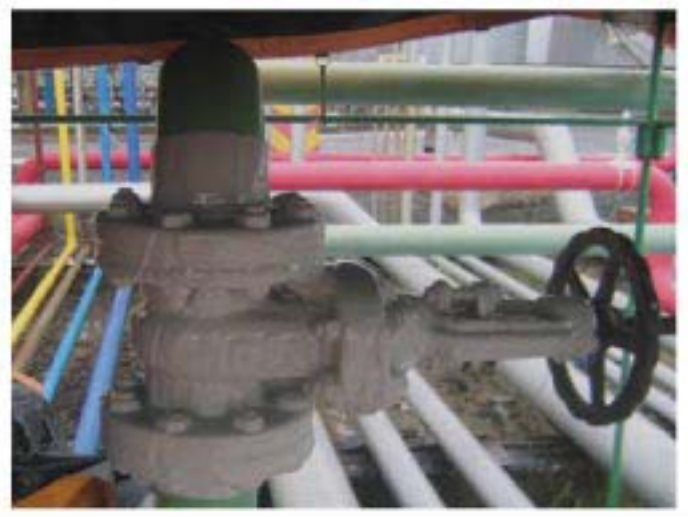
1.5c – Before and After the application on flange heads and globe valves

Protection of the substrate surfaces is assured with the use of Oxifree however complicated the shape as you can see below.
